Cyclone Larry Fieldwork (RAMP)

Introduction

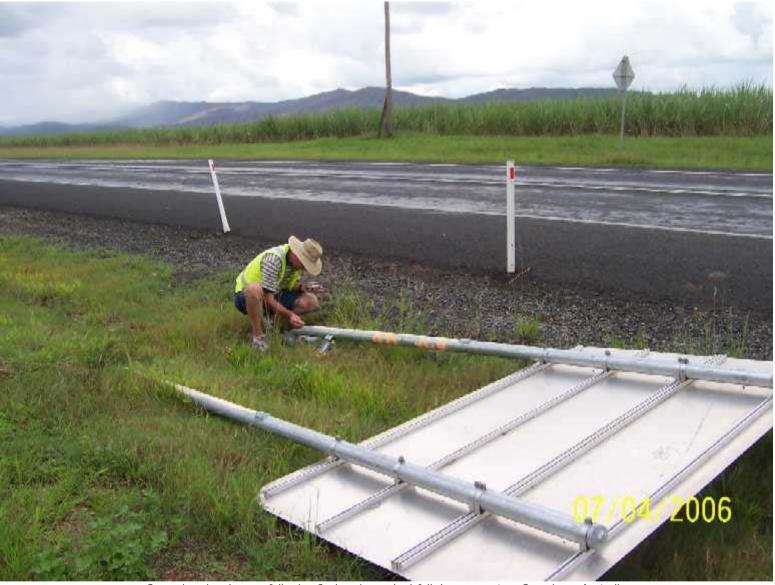
Surveying sign damage following Cyclone Larry, Innisfail. Image courtesy Geoscience Australia.

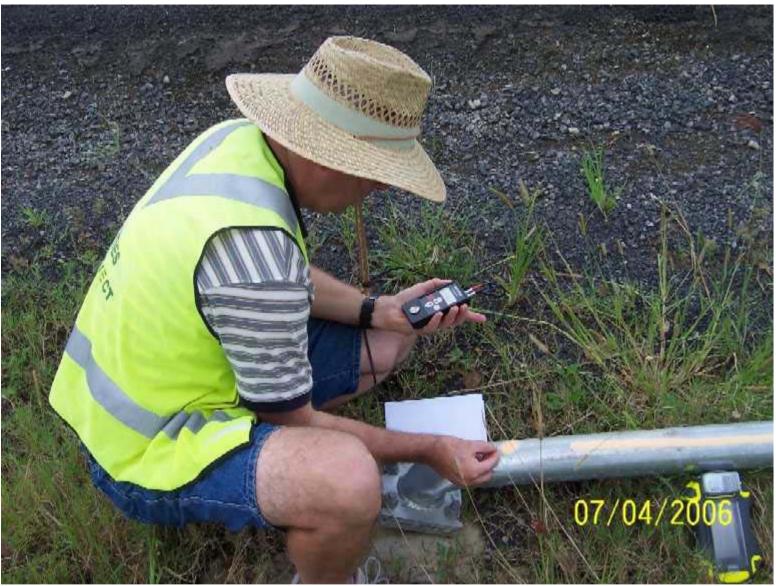
Calculating the wind speed of Cyclone Larry by measuring the damage to steel posts. Image courtesy Geoscience Australia.

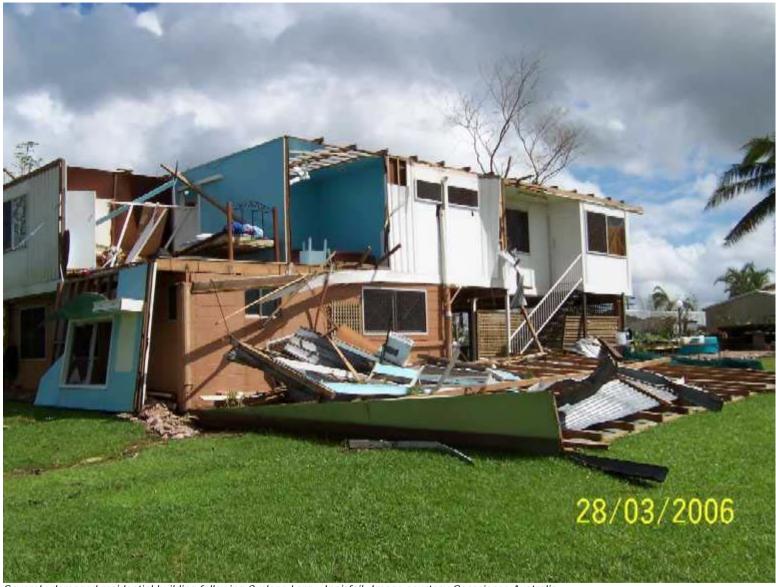
Severely damaged residential building following Cyclone Larry, Innisfail. Image courtesy Geoscience Australia.

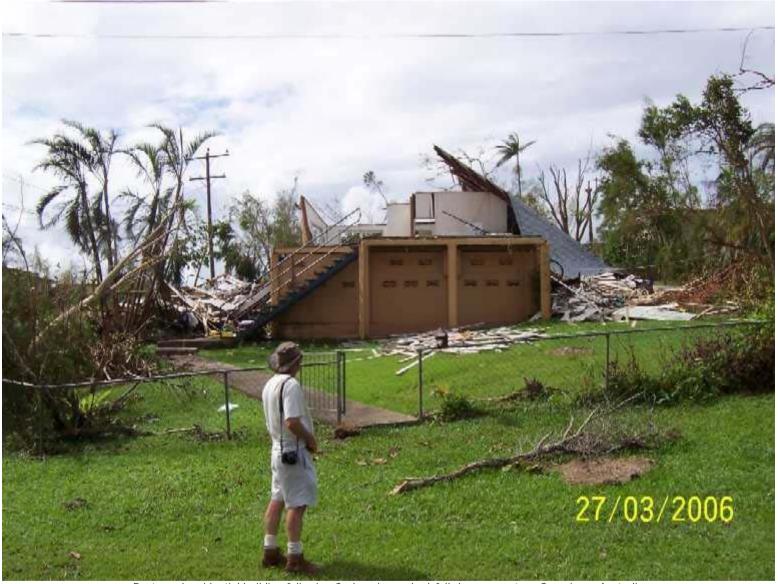
Destroyed residential building following Cyclone Larry, Innisfail. Image courtesy Geoscience Australia.

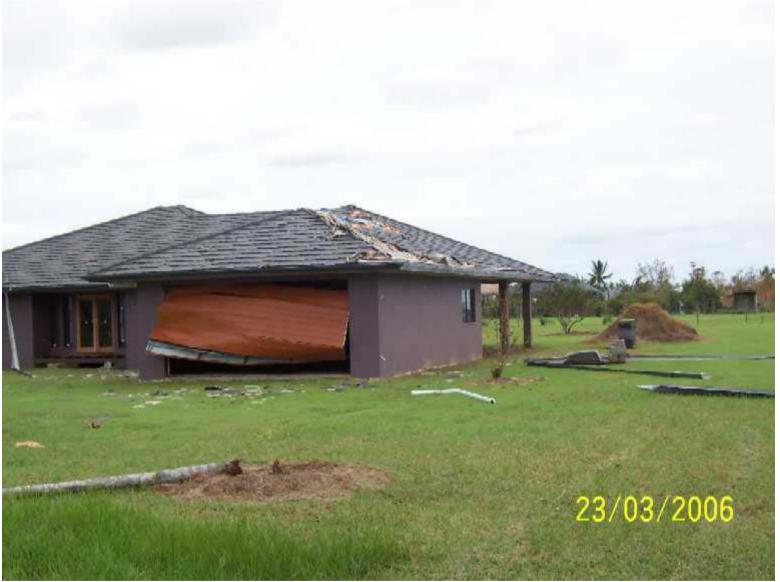
Damage to newer homes tended to be comparatively minor and was mostly limited to garage doors, roof tiles, fascias and guttering.

Damaged to a new residential building following Cyclone Larry, Innisfail. Image courtesy Geoscience Australia.

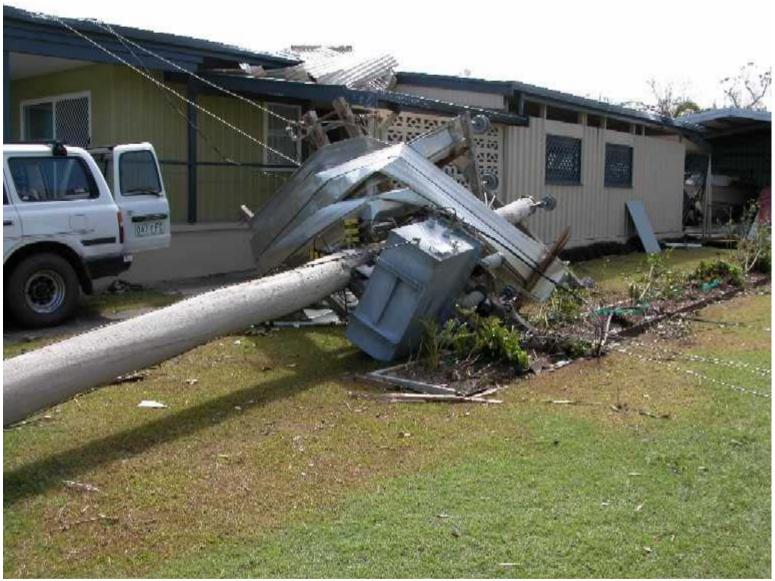
Power pole damage to a residential building following Cyclone Larry, Innisfail. Image courtesy Geoscience Australia.

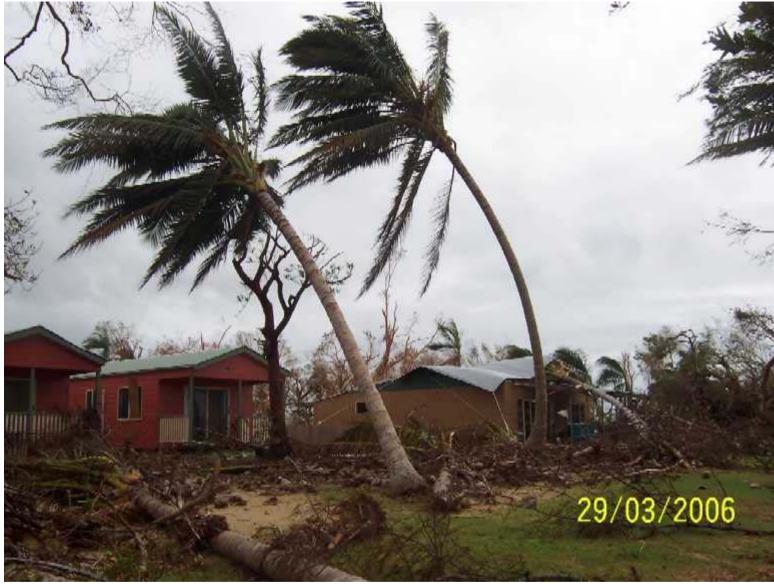
Tree damage to residential buildings following Cyclone Larry, Innisfail. Image courtesy Geoscience Australia.

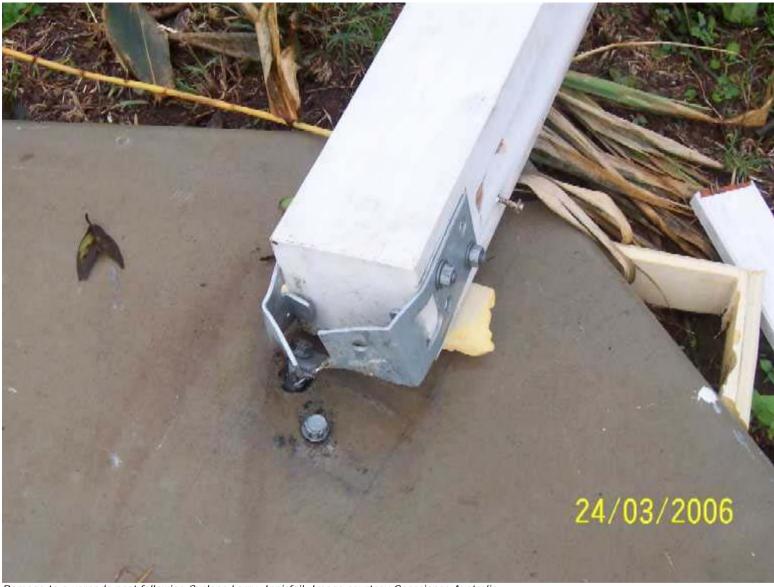
Damage to a veranda post following Cyclone Larry, Innisfail. Image courtesy Geoscience Australia.

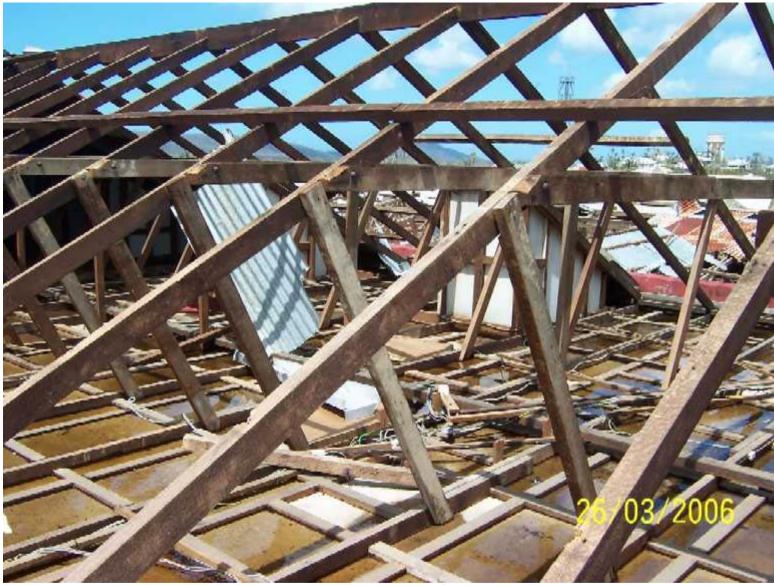
Roof damage to a residential house following Cyclone Larry, Innisfail. Image courtesy Geoscience Australia.

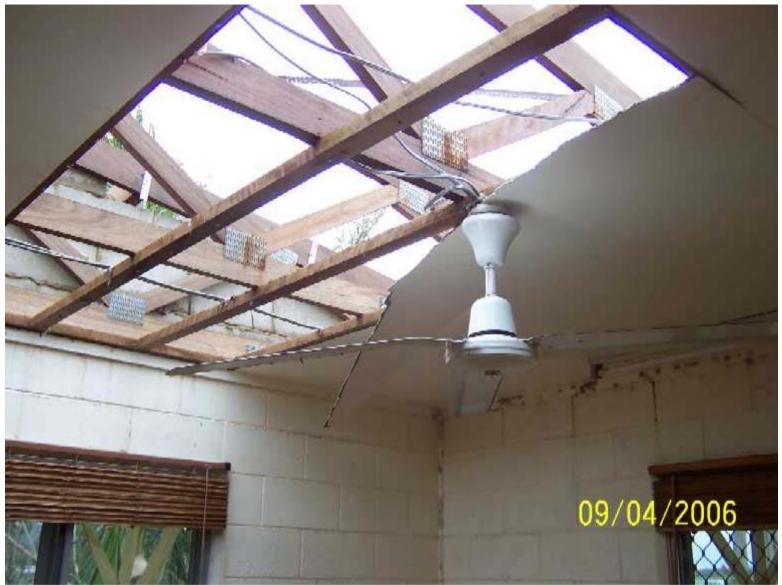
Internal damage to a residential house following Cyclone Larry, Innisfail. Image courtesy Geoscience Australia.

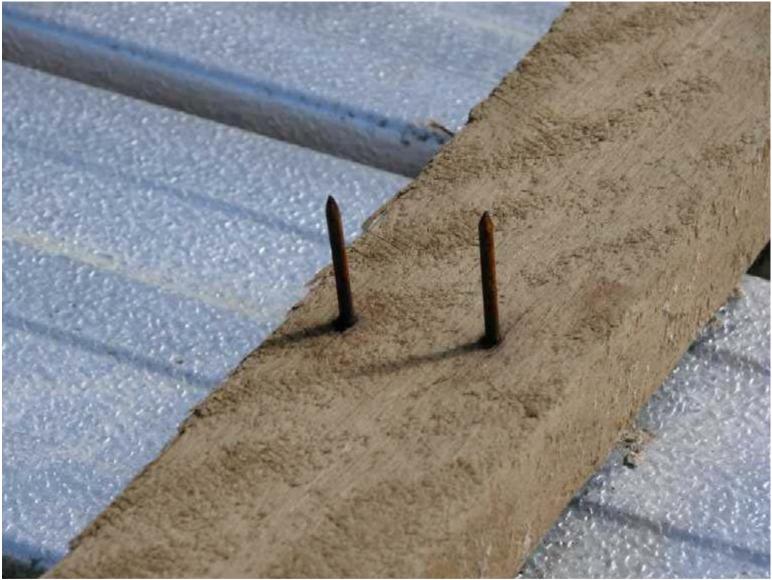
equal to 25% of the value of the structures in the local population). *Figure 3 (right): Damage index (DI) for Cyclone Larry. Click to enlarge.* Among residential properties, older homes (pre-1986) tended to suffer the greatest wind damage due to their vulnerable locations (e.g. on ridge tops), building regulations requiring limited cyclone-resistance measures at the time of construction, and their lower resilience through aging processes (corrosion, rot, insect attack).

Rusted nails used in the construction of a residential house, Innisfail. Image courtesy Geoscience Australia.

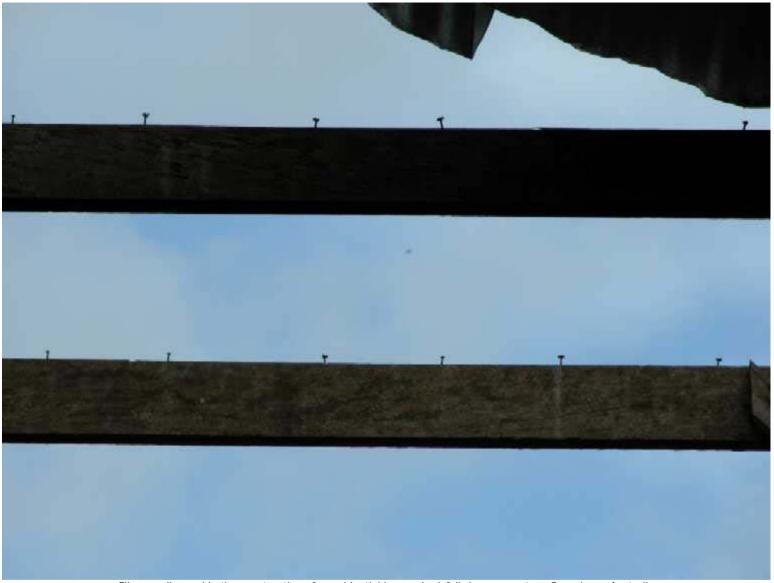
Flimsy nails used in the construction of a residential house, Innisfail. Image courtesy Geoscience Australia.

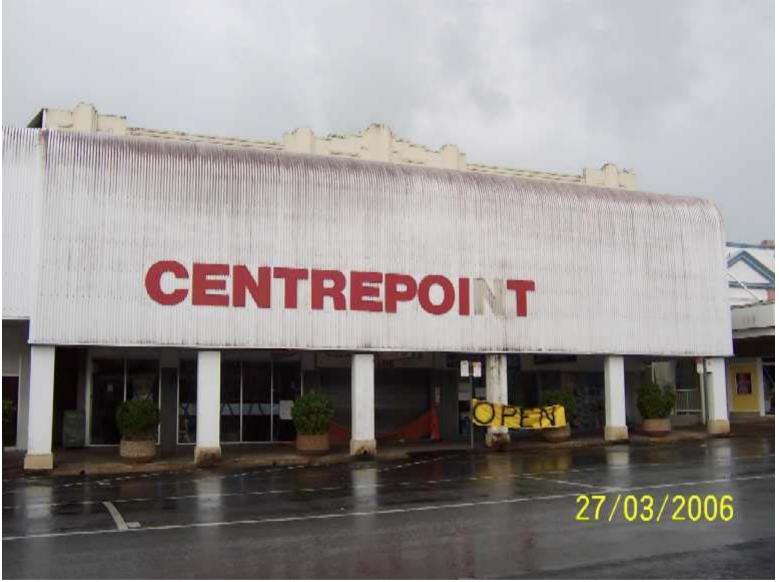
Commercial building damage following Cyclone Larry to "Centrepoint", Innisfail. Image courtesy Geoscience Australia.

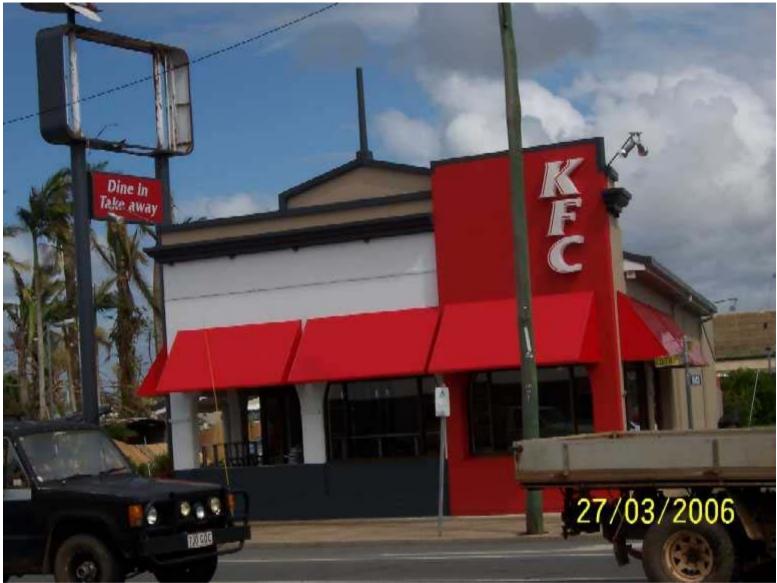
Commercial building damage following Cyclone Larry to "KFC", Innisfail. Image courtesy Geoscience Australia.

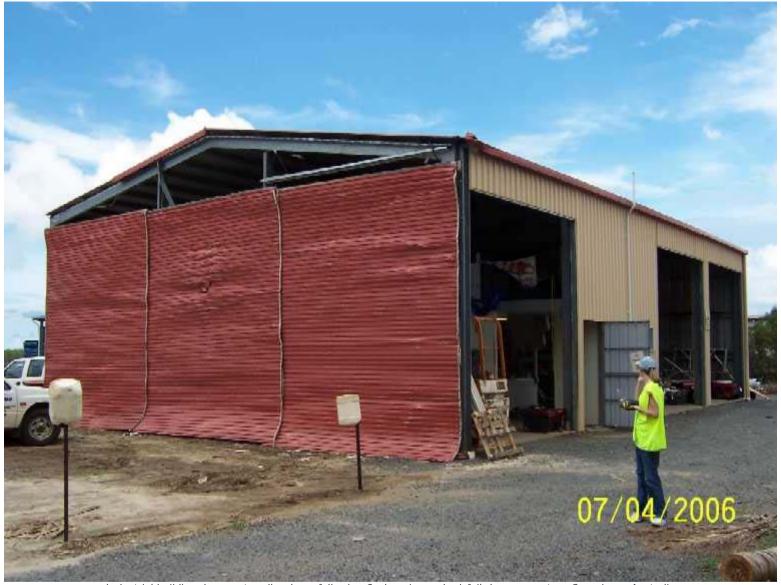
Industrial building damage to roller doors following Cyclone Larry, Innisfail. Image courtesy Geoscience Australia.

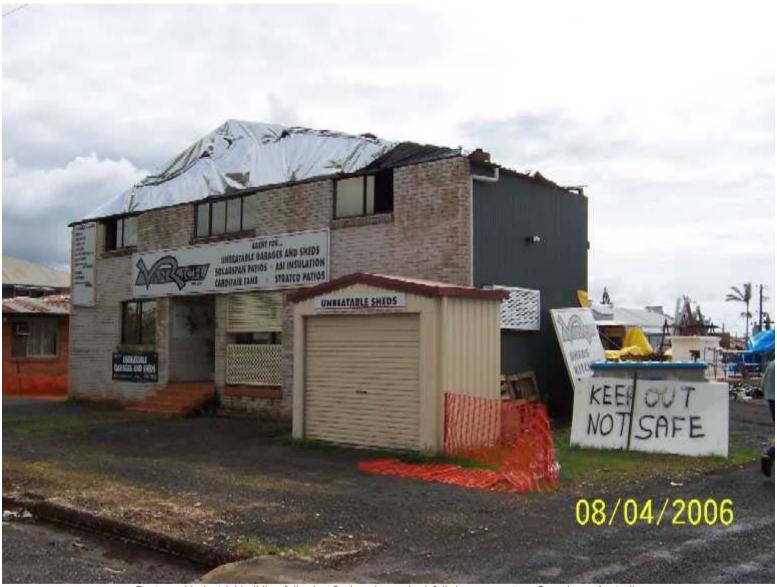
Destroyed industrial building following Cyclone Larry, Innisfail. Image courtesy Geoscience Australia.

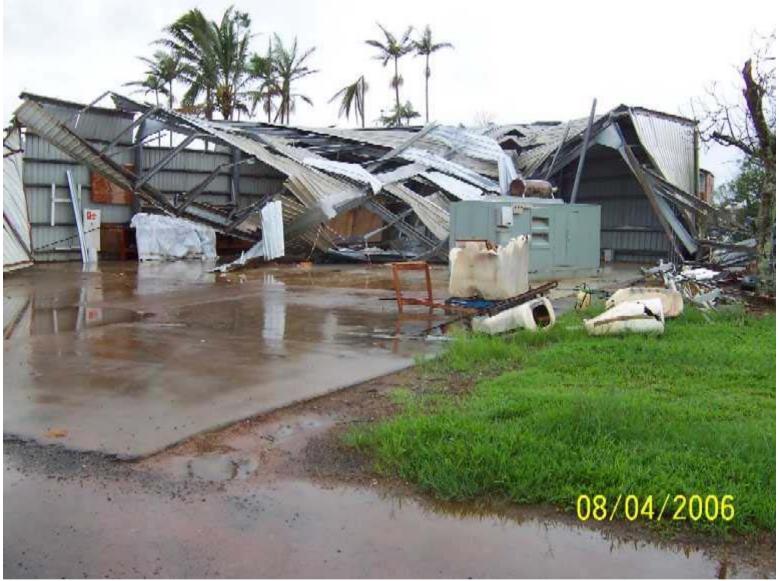
Destroyed industrial building following Cyclone Larry at an airfield near Innisfail. Image courtesy Geoscience Australia.

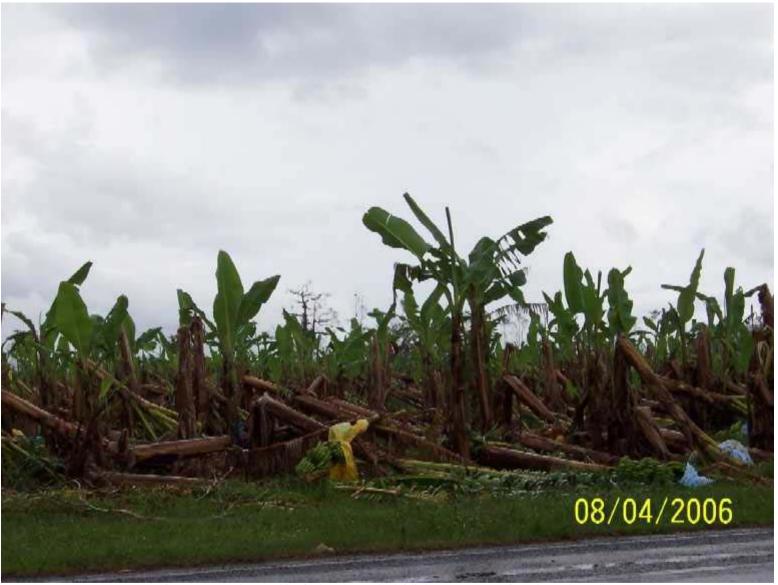
Banana crops damaged by Cyclone Larry, Innisfail. Image courtesy Geoscience Australia.

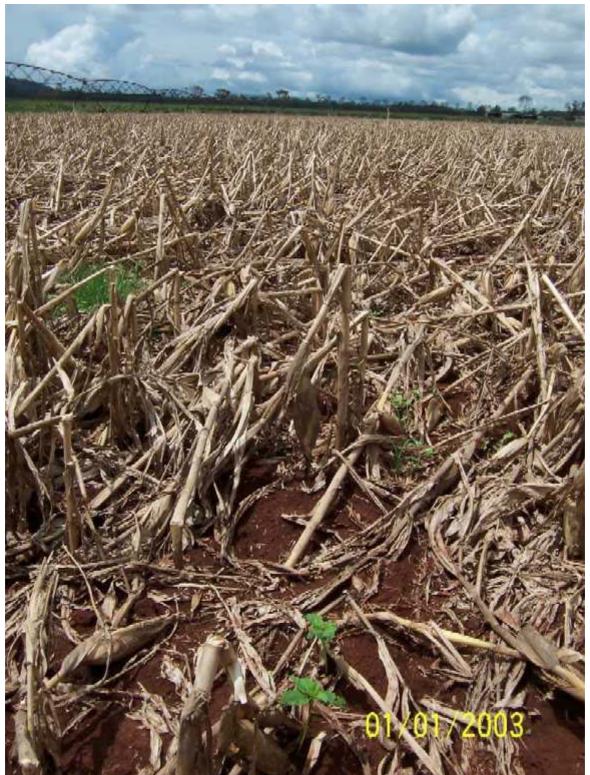
Sugar cane damaged by Cyclone Larry, Tablelands. Image courtesy Geoscience Australia.

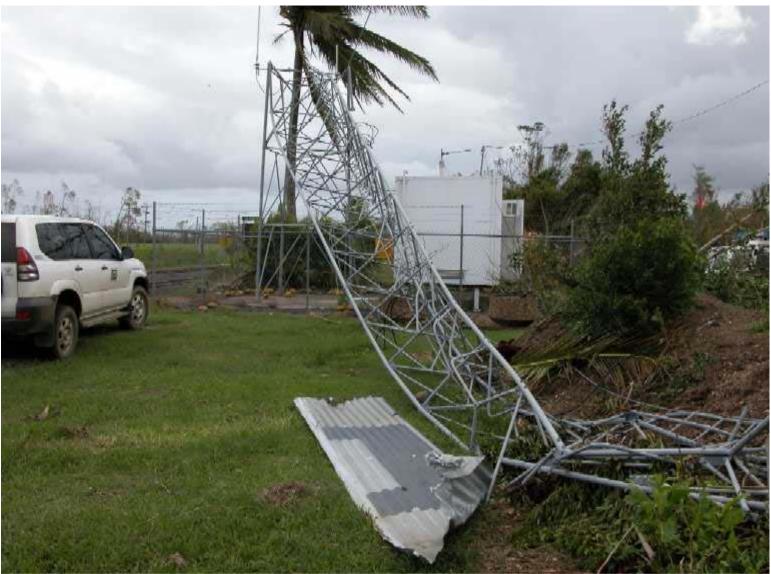
Antenna damaged by Cyclone Larry, Innisfail. Image courtesy Geoscience Australia.

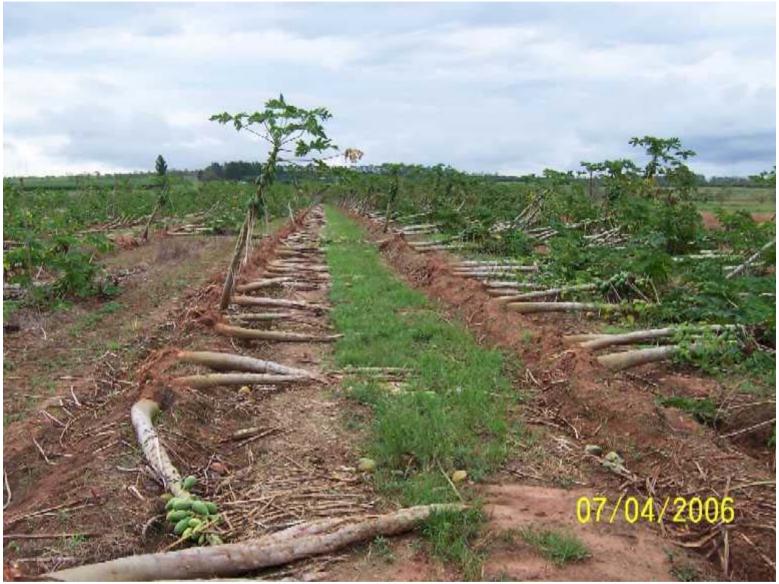
Paw paw crops damaged by Cyclone Larry, Tablelands. Image courtesy Geoscience Australia.

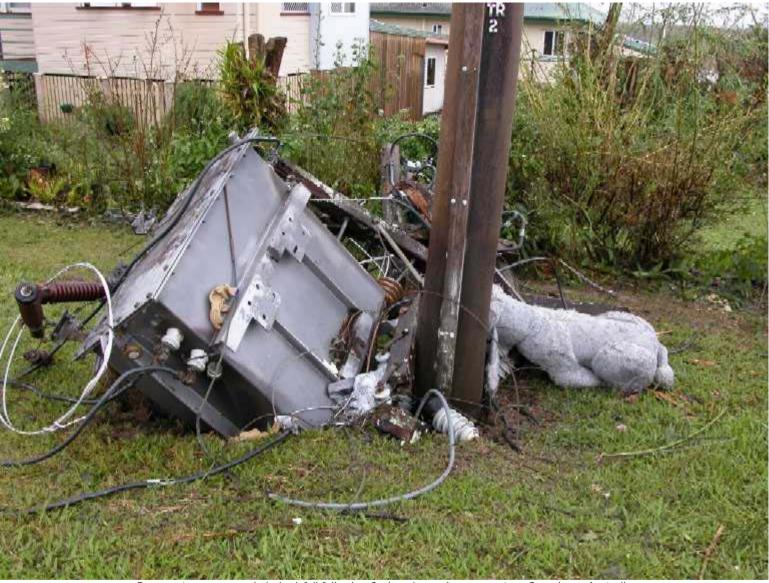
Damage to power supply in Innisfail following Cyclone Larry. Image courtesy Geoscience Australia.

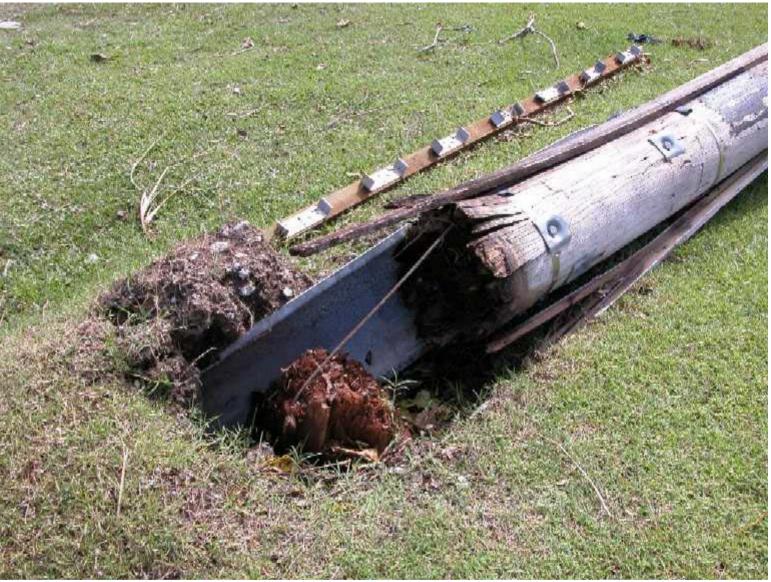
Damage to a power pole in Innisfail following Cyclone Larry. Image courtesy Geoscience Australia.

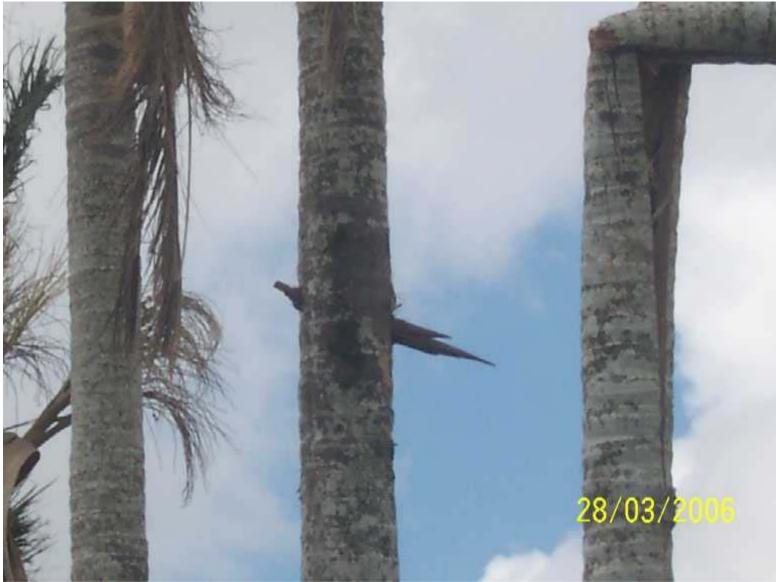
Wooden stake embedded into a tree due to the high and powerful winds caused by Cyclone Larry. Image courtesy Geoscience Australia.

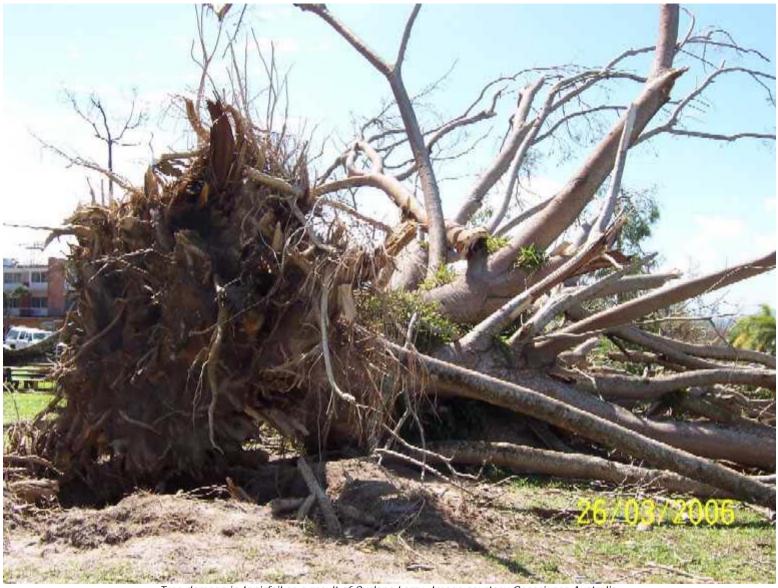
Tree damage in Innisfail as a result of Cyclone Larry. Image courtesy Geoscience Australia.
