Cyclone Larry Fieldwork (RAMP)

Introduction

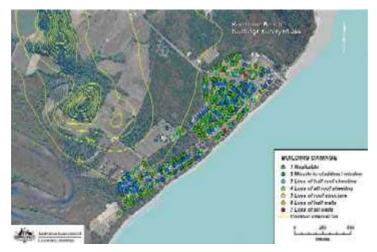
buildings. All townships in the Innisfail region were severely affected. *Figure 2 (left):* Kurrimine Beach GIS example. Click to enlarge.

The assessed damage index, which expresses the repair cost as a proportion of the value of rebuilding damaged residential structures (*Table 1*), was calculated for buildings within a number of Innisfail suburbs and nearby townships. *Figure 2* gives an example of the spatial analysis conducted for the

community of Kurrimine Beach (30 kilometres south-southeast of Innisfail). *Figure 3* displays the results as a population percentage (e.g. 25% indicates a damage level

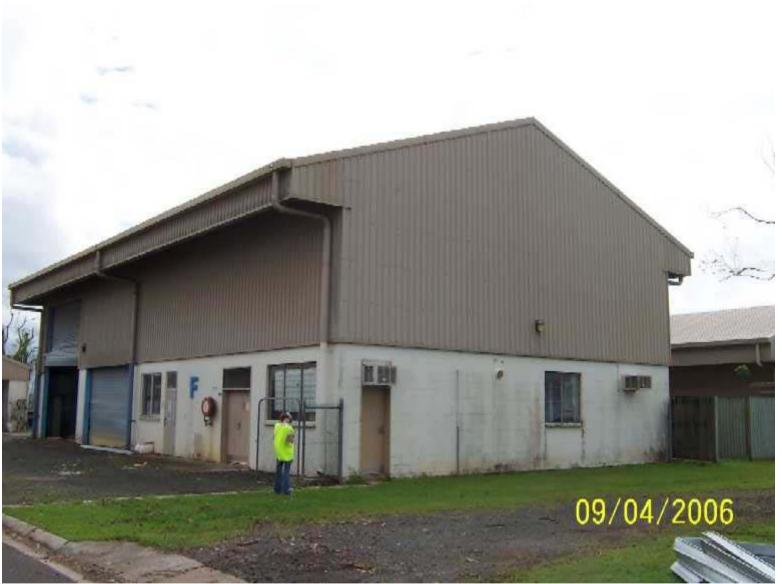
GA team member surveying damage to an industrial building following Cyclone Larry, Innisfail. Image courtesy Geoscience Australia.

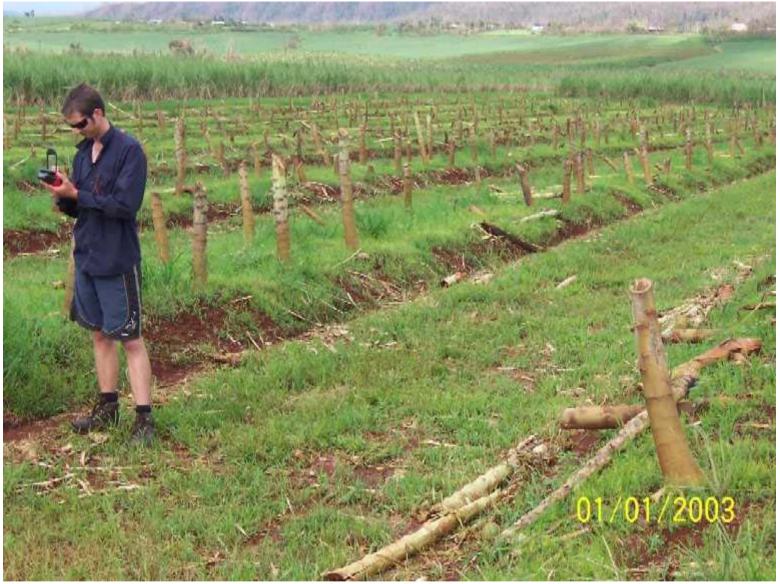
Surveying paw paw crops damaged by Cyclone Larry, Tablelands. Image courtesy Geoscience Australia.
